**Environmental Impact Statement for
Proposed Demolition and
Environmental Cleanup Activities at
Santa Susana Field Laboratory,
Ventura County, California**

Prepared for
National Aeronautics and Space Administration

July 2013

2011 Supplemental Biological Surveys of NASA-Administered Property at Santa Susana Field Laboratory

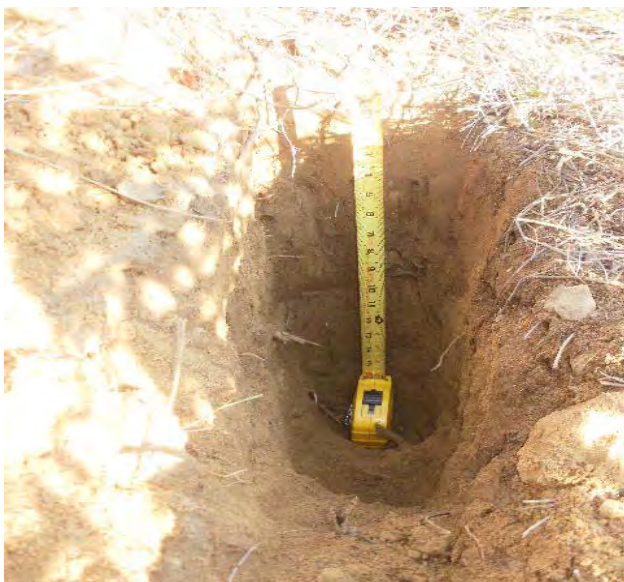
G-3. Coca Pond SP-2 soil pit (out). January 3, 2012

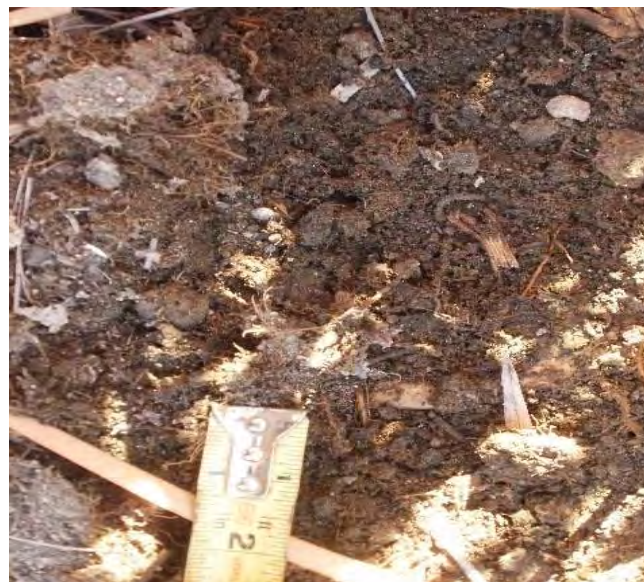
G-4. Coca Pond. Organic sediment accumulation at SP-1. January 3, 2012

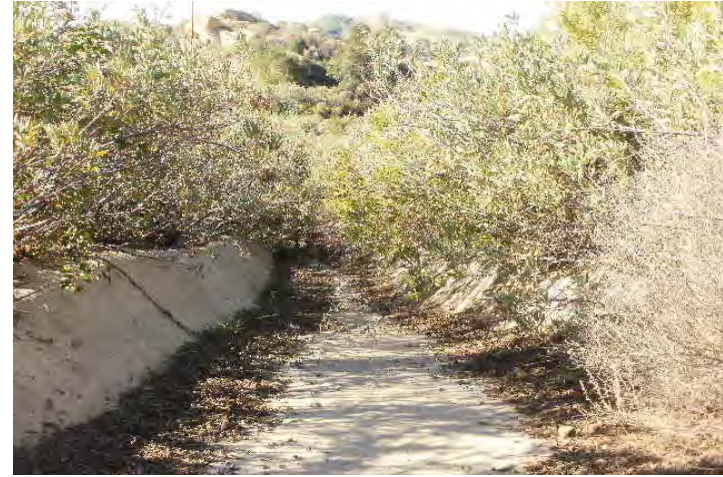
G-6. Bell Creek Tributary (Coca Drainage below Coca Pond). View east (downstream) of concrete lined ditch just below Coca Pond outlet at stream data point CD-3. January 3, 2012.

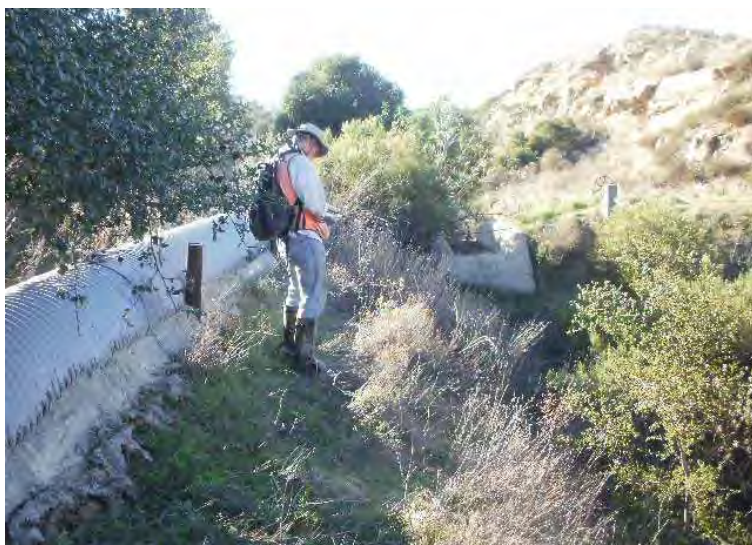
G-27. Bell Creek at Alfa Site. Earthen dam along Bell Creek view west-northwest. January 5, 2012

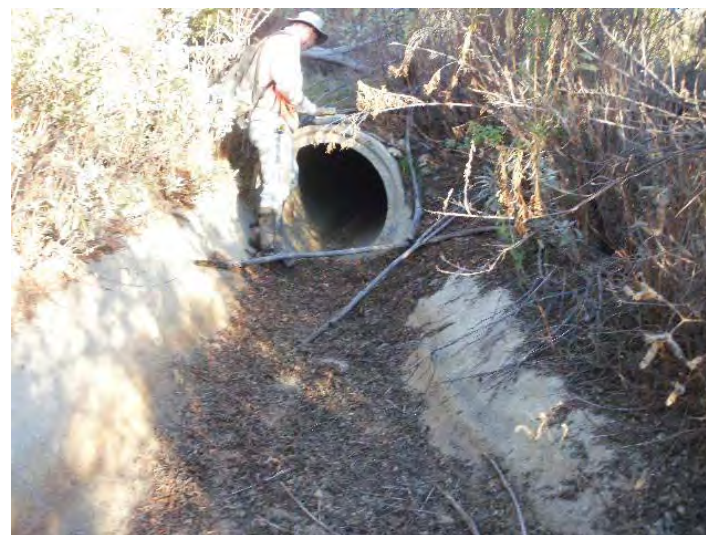
G-28. Bell Creek at Bravo Site. Culvert discharge below and north of capped pond outfall. January 5, 2012

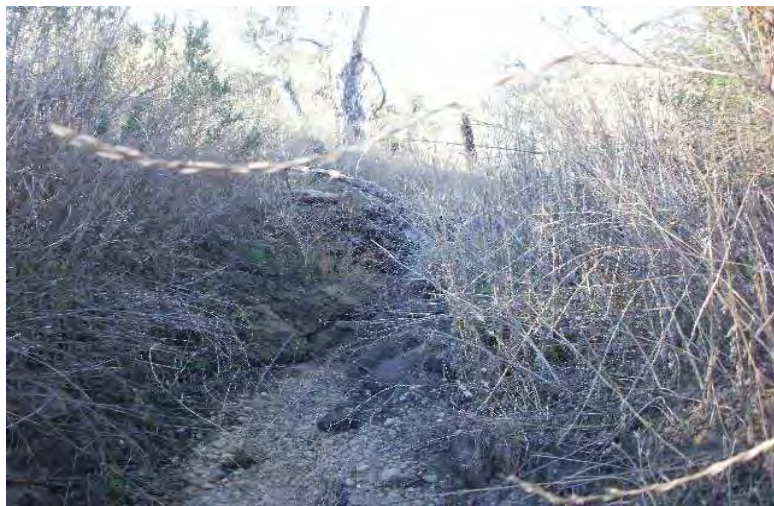
G-29. Bell Creek at SPA Site. View west (downstream) at stream data point BC-6. January 6, 2012. [Designated in report as BC-6]

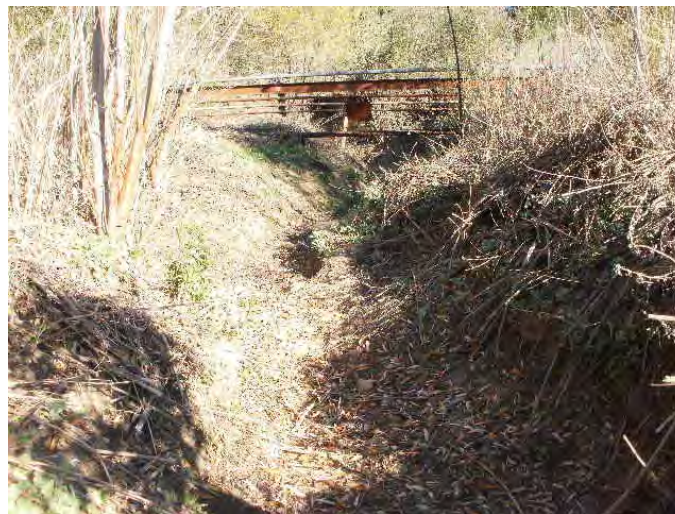
G-30. Bell Creek near CDFF Site. View north (upstream) at stream data point BC-8 above R2B Pond. January 6, 2012.

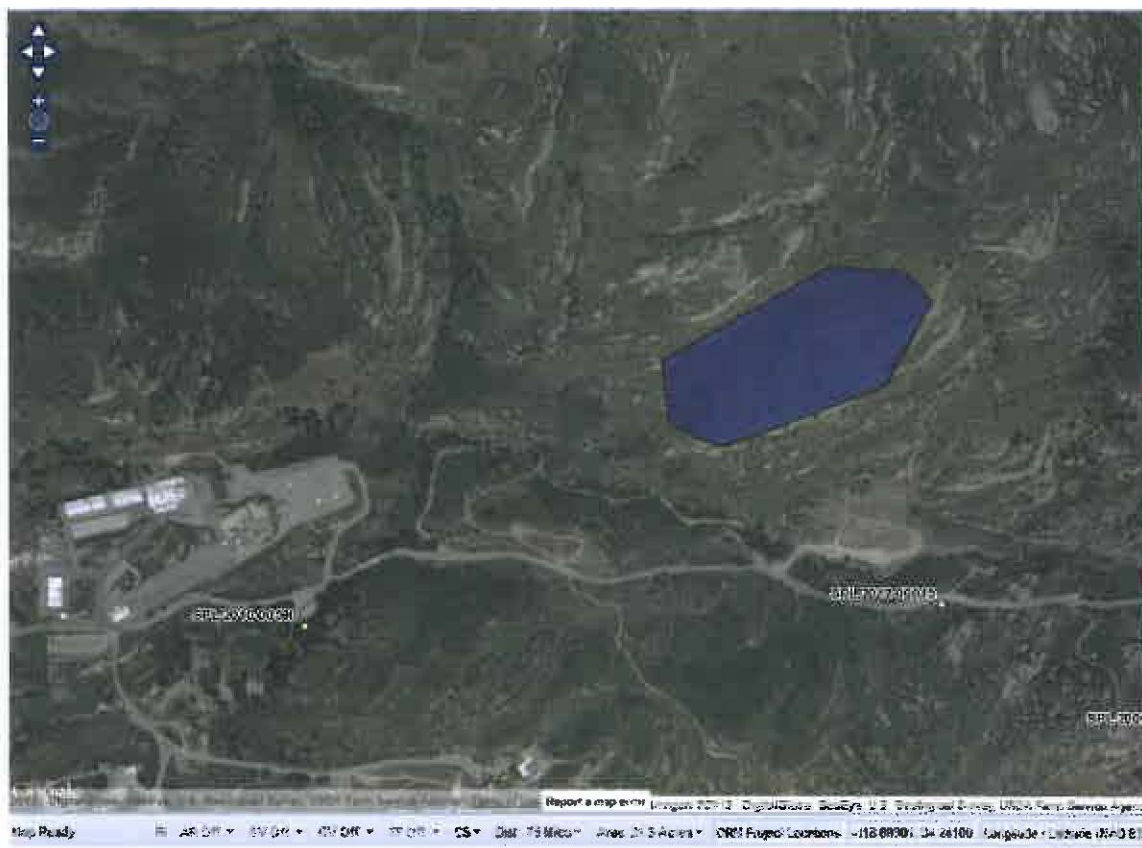
SW-2 pond drainage area (approx 20 acres)

north, east and south.. The drainage area of the pond is estimated to be approximately 20 acres. A small area of ponded water was evident within the larger feature during a 12/20/2012 site visit. No evidence of outflow (scour, debris deposits, etc) was observed. The nearest drainage feature, an ephemeral drainage channel ("northern drainage") ultimately draining to Calleguas Creek, is approximately 500 lateral feet and 100 vertical feet removed from the pond at its nearest point. No sources of interstate commerce were identified.

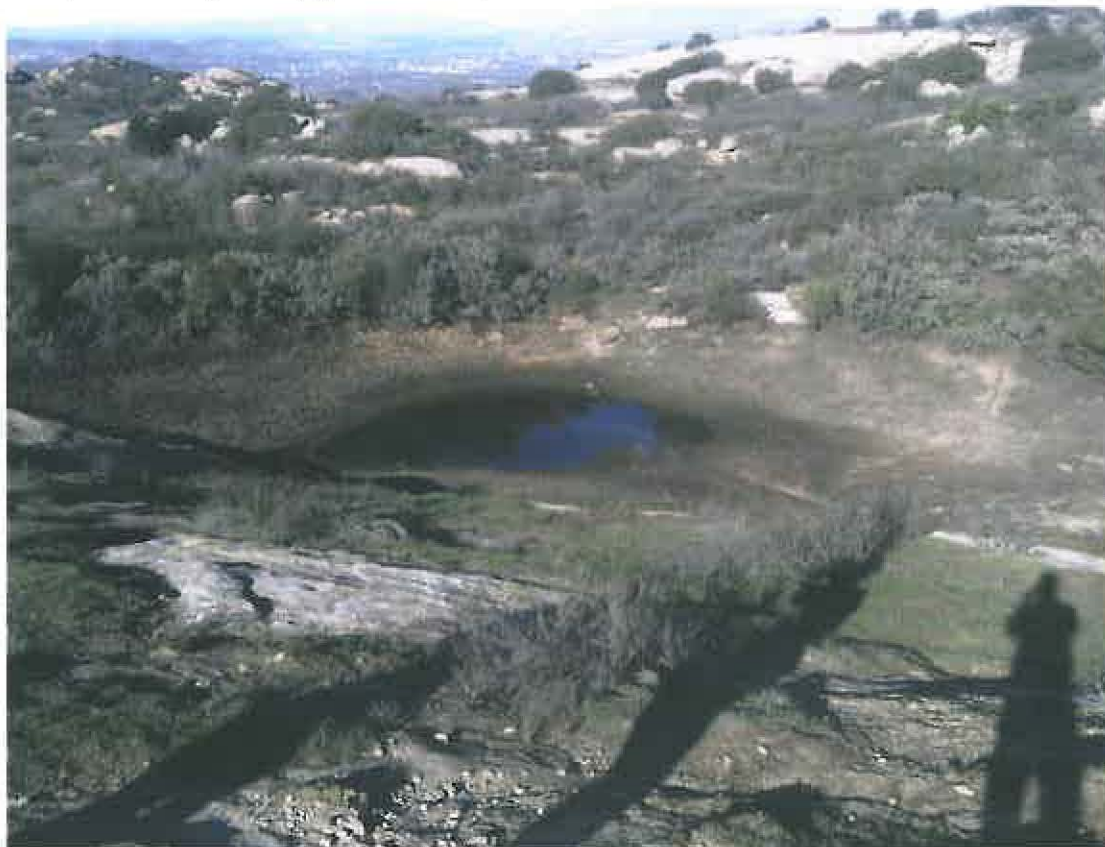
SW-2 pond (12/20/2012)
